PA 474
(PA NO NAME No. 35)
MERCER COUNTY, COMMONWEALTH OF PENNSYLVANIA
NDI No. PA 00249
PennDER No. 43-50
SCS No. PA 474

PHASE I INSPECTION REPORT
NATIONAL DAM INSPECTION PROGRAM

PA 474 (PA No Name No. 35), Mercer County, Pennsylvania
NDI No. PA 00249, PennDER No. 43-50, SCS No. PA 474
Saw Mill Run
Inspected 9 May 1979

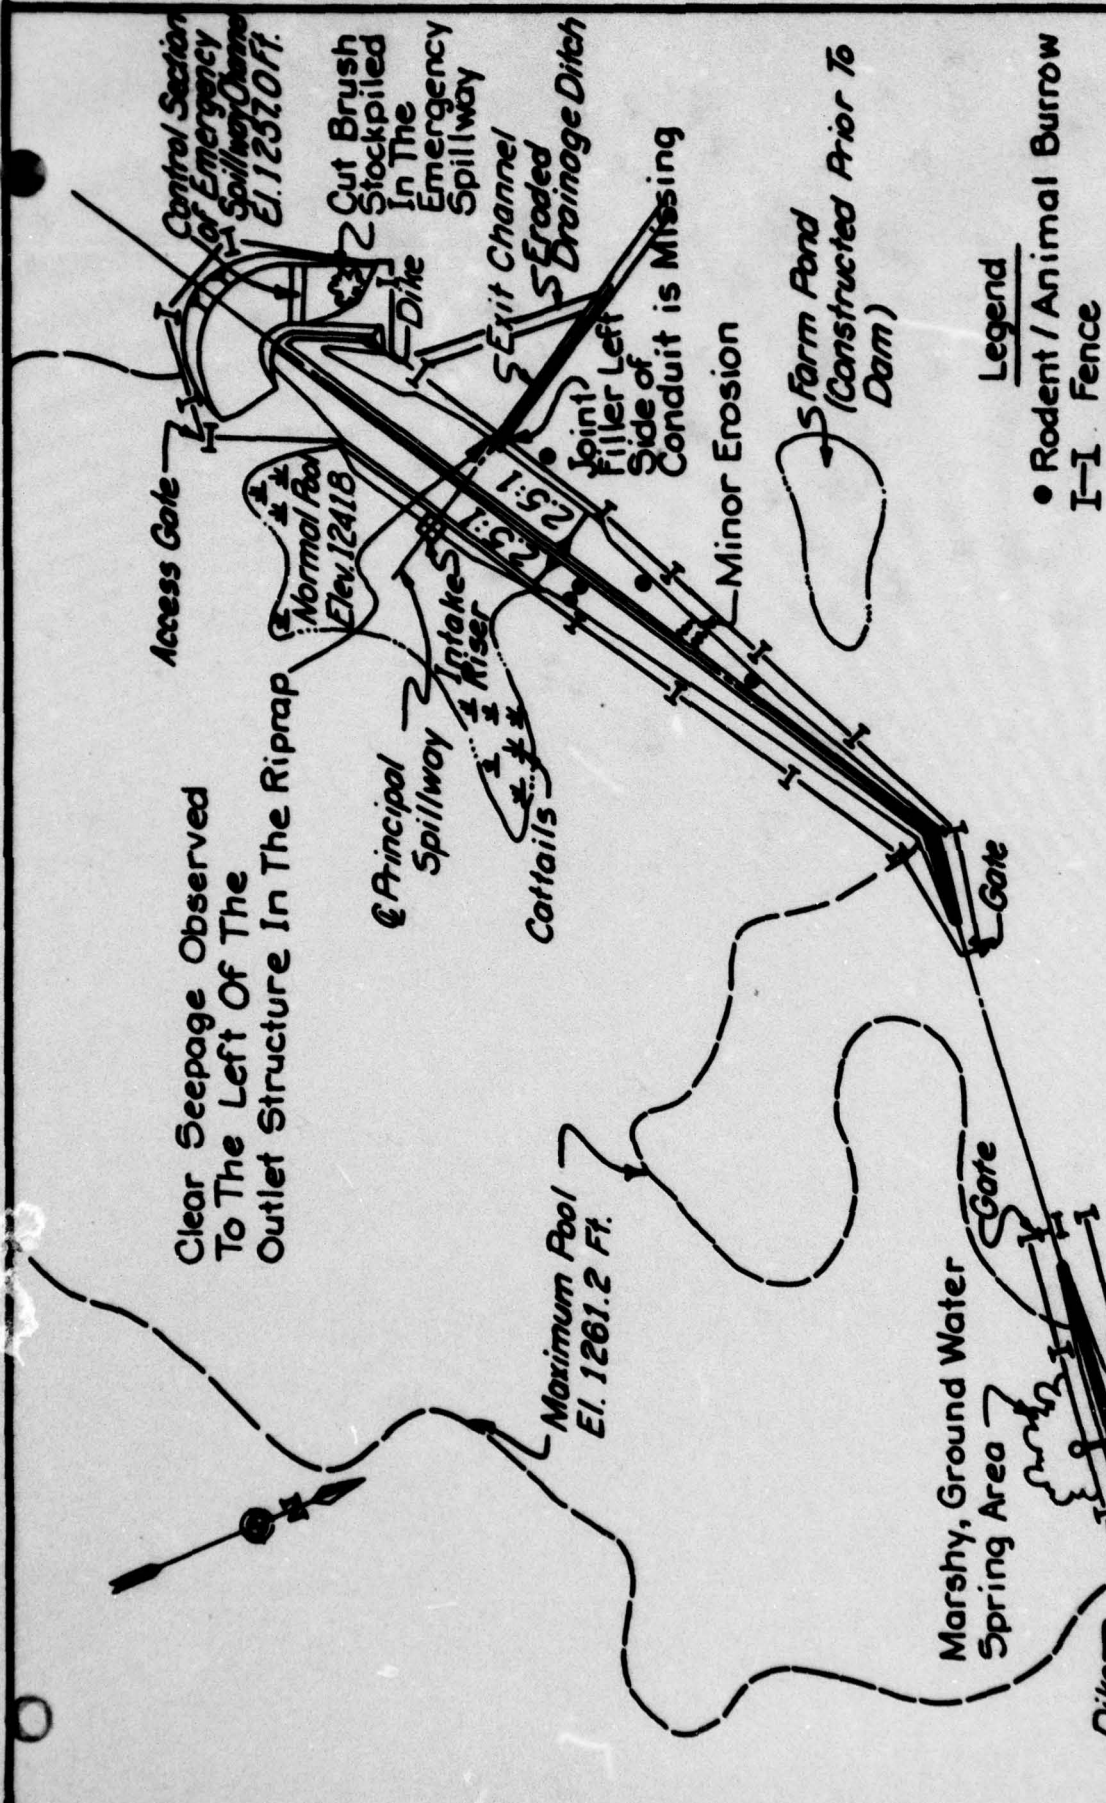
FIELD SKETCH

Several rodent/animal burrows were observed in the embankment. The locations of these holes are shown on the field sketch.

<u>VISUAL EXAMINATION OF</u>	<u>OBSERVATIONS</u>	<u>REMARKS OR RECOMMENDATIONS</u>
RODENT/ANIMAL BURROWS	Several rodent/animal burrows were observed in the embankment. The approximate location of these holes are shown on the field sketch.	The holes should be repaired.
JUNCTION OF EMBANKMENT AND ABUTMENT, SPILLWAY AND DAM	No problems observed	
ANY NOTICEABLE SEEPAGE	Minor seepage was observed to the left of the outlet structure (impact basin) wall. Clear flow of approximately 0.5 g.p.m. at the time of inspection.	This area should be observed periodically in the future to identify any changes in characteristics.
STAFF GAGE AND RECORDER	None installed	
DRAINS	Two 6-in. corrugated metal drainpipes enter the impact basin (one on each side). The left drain was flowing with clear water, approximately 1.5 in. deep in the invert (approximately 15 g.p.m.). The right drain was clogged. After unclogging, the drain flowed full for approximately five minutes and eventually tapered off to a slow trickle.	These drains shall be inspected periodically for turbidity, volume of flow and blockage.

- 4) Fill the animal burrows in the embankment and establish a rodent control program.
- 5) Replace the joint filler between the outlet conduit and the impact basin head wall.
- 6) Periodically inspect and maintain the filter drain outlets.
- 7) Clear the debris from the trash rack of the riser and periodically inspect and maintain the trash rack in the future.

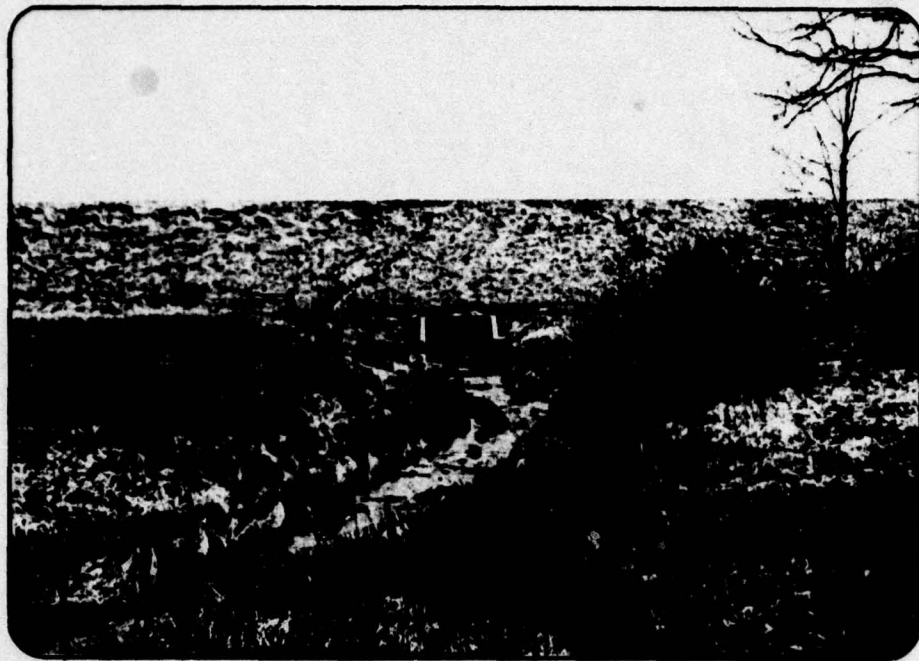
PHOTO 3. Downstream Slope of Dam, Outlet Structure and Outlet Channel
